Root Canal Retreatment*

Abstract: Root canal therapy is not always successful and an increasing number of patients are requesting retreatment to address intraradicular infection. The armamentarium available to assist the dentist, some of which is described in this article, has never been greater.

Dent Update 2006; 33: 518-530

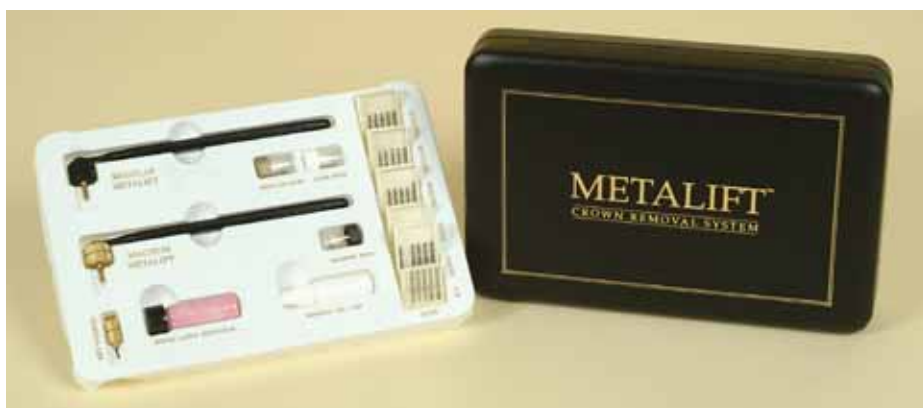
Figure 1. Photograph of the Metalift system. A small hole is drilled in the occlusal surface of the restoration prior to the introduction of a self-threading screw which pushes against the dentine/core and elevates the crown, thus breaking the cement seal.

Sectioning and removal of crowns or bridges, with careful consideration being given as to the method of temporization, is preferred to tapping them off with a crown remover. The latter method is uncontrolled and may result in unnecessary fracture of tooth tissue, with subsequent restorative complications. It is advisable to initiate sectioning with a diamond bur if porcelain is involved, otherwise the transmetal bur provides an excellent means of cutting through metal crowns. A recent device, the Metalift (Figure 1) has been introduced, which allows crowns to be removed intact. The procedure involves drilling a small hole in the occlusal surface of the restoration prior to the introduction of a self threading screw which pushes against the dentine/core and elevates the crown, thus breaking the cement seal.

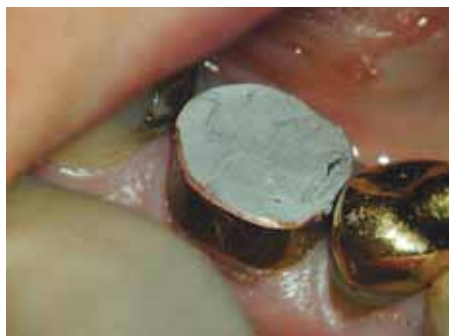
Figure 2. Photograph of tooth restored with copper ring and amalgam prior to re-root treatment; composite or resin re-enforced glass ionomer or orthodontic bands may also be used.

In cases of extensive breakdown, it may be necessary to place a copper ring (Figure 2) or orthodontic band and build a

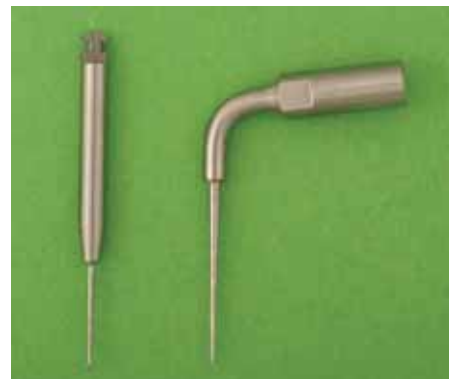
Figure 5. Photograph of an LN bur and small ultrasonic tip showing comparison in size.

The fracture of a post within a root canal may pose a major problem and care should be taken to try not to weaken, fracture or perforate the root further. Such situations should first be tackled by troughing around the post to remove the luting cement, using a small long neck bur or thin ultrasonic tip (Figure 5).

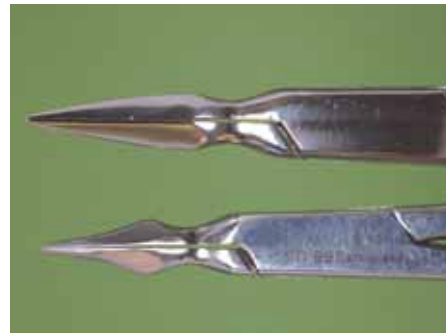
If the silver point has been cut off at the canal orifice, then it is generally not possible to grip it. In such situations, an

a Hedstrom file alongside the point to aid elevation, with or without ultrasonic vibration.

Silver points are round in cross-section and therefore rarely seal canals adequately. Leakage occurs when sealer washes out, with subsequent corrosion leading to failure of the root canal filling. The approach to removal depends on whether the point extends and can be seen to extrude within the pulp chamber. In such situations, silver point snugness should be assessed by grasping with Steiglitz forceps (Figure 8) and levering gently, using the coronal aspect of the tooth as a fulcrum. Loose points will be easily removed in this manner and gentle manipulation is unlikely to remove valuable coronal silver point, which may be required for future grasping and extraction attempts. If the points cannot be removed easily, then ultrasonic vibrations can be applied to the forceps holding the point.

ultrasonic tip may be used to cut a trough around the point. Care needs to be taken not to touch the point, as the silver is much softer than the steel used for manufacture of the ultrasonic tip, and preferential removal of the point will occur. A variety of removal techniques may be employed to grip the point and remove it once a trough approximately 2 mm deep has been prepared, such as a Masserann extractor (Figure 9a), Ruddle IRS (Figure 9b) or tube and glue/composite (see fractured instrument removal section). A silver point retreatment case is illustrated in Figures 9 c–e. On occasions it may be necessary to work a size 15 ultrasonic file down the side of a point placed deep in a root canal. Removal in these situations may be facilitated by placing

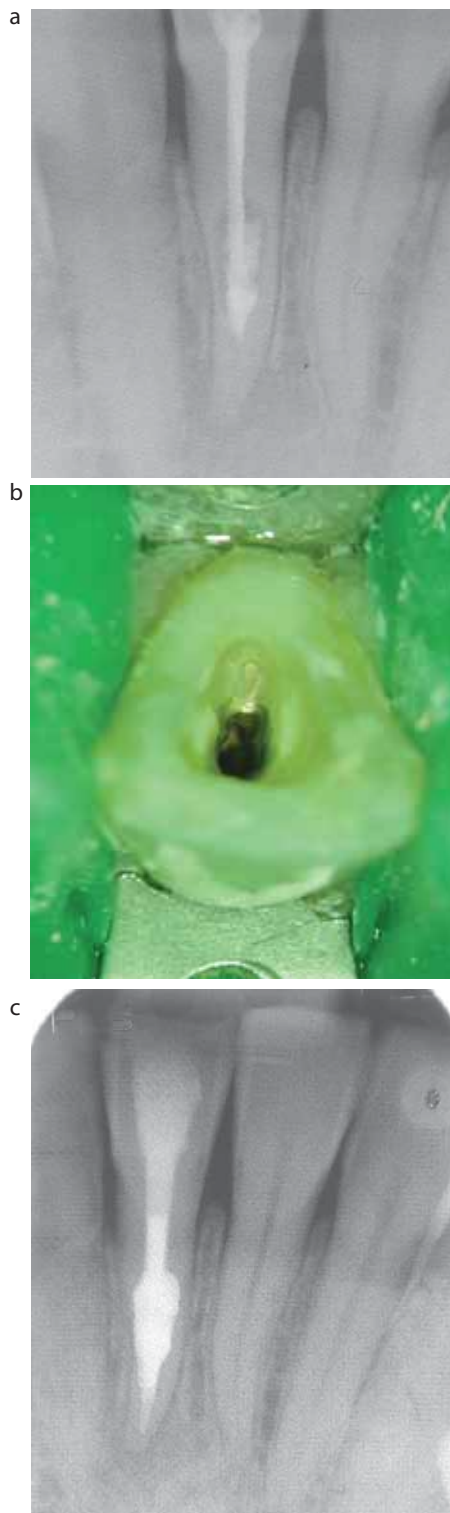
Figure 10. A carrier retreatment case where the carrier was bypassed, solvents and files prior to the use of a rotary NiTi file, and Steigitz forceps were used to remove the carrier: **(a)** pre-operative radiograph; **(b)** photograph following removal showing lingual fin/canal; **(c)** postoperative radiograph.

remove gutta-percha, create space in larger canals and may locate a groove on the side of the carrier to pass a rotary NiTi file alongside and frequently elevate the point. If this is not successful, then grasping or elevation techniques, as described in the silver point section, may be employed (Figures 10a–c).

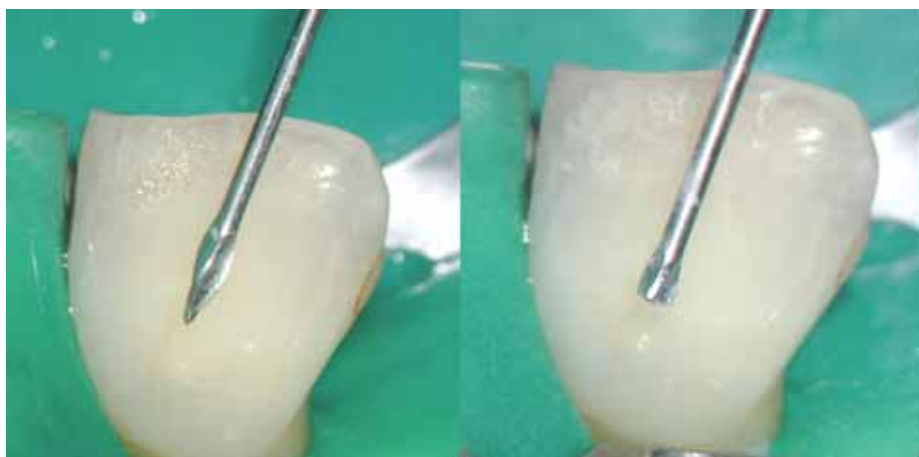
Figure 11. Photograph of unmodified and modified belly Gates-Glidden drills.

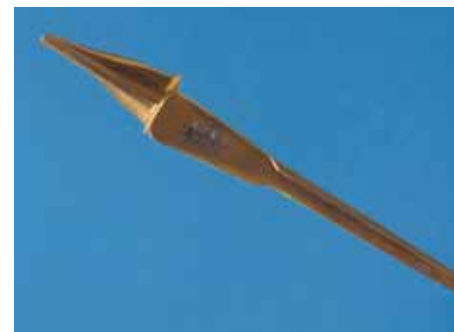
Figure 15. Buchanan file bender which may be used to place a small bend on the end of a file to help negotiate ledged canals.

and introduction of a small file with a curve, placed in its apical few millimetres, using a file bender (Figure 15). This instrument is directed towards the curvature and used to pick and probe the depths of the canal until a catch or bite is sensed. If this is not initially successful, then the file is removed and recurved or, alternatively, a new file substituted. Blockage and ledge negotiation may result in many small files being discarded. Once a bite is felt, then the file is moved in and out in small increments to smooth the path and advance apically. A very light watchwinding movement may also be employed with care. Files are advanced in this manner to the end of the canal, up to size 20, and the preparation may be smoothed using precurved 06 (white) and 08 (yellow) Hand GT files in reverse balanced force.
